EKATI DIAMOND MINE

ENVIRONMENTAL AGREEMENT AND WATER LICENCE

ANNUAL REPORT SUMMARY 2019

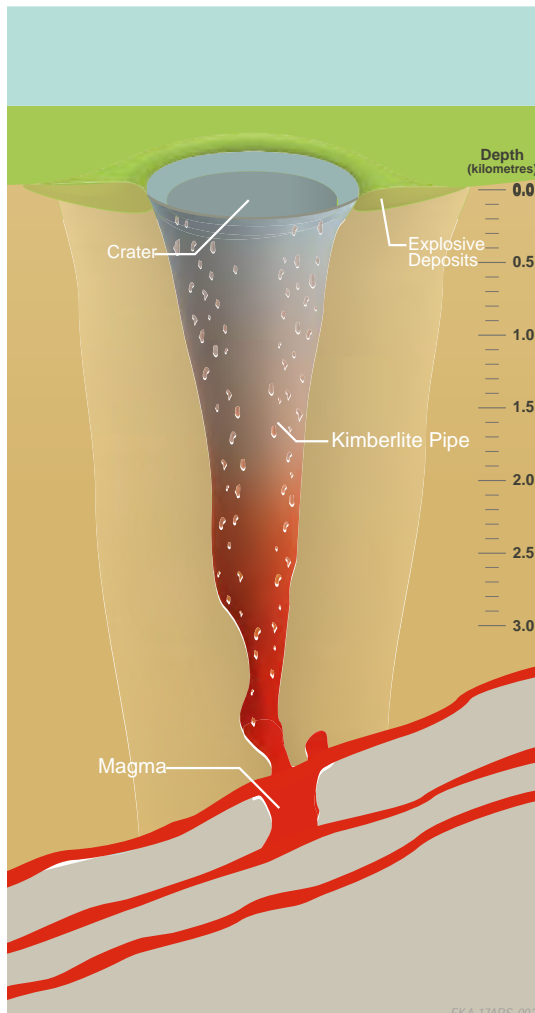
Figure 2
Structure of a kimberlite pipe.

At the Ekati Diamond Mine, miners use two methods to remove the diamond-rich kimberlite ore from the ground: open pit mining and underground mining. In open pit mines, workers remove waste rock and earth to get to the kimberlite pipe using digging equipment and explosives. In underground mines, spiral-shaped tunnels are built to allow mining equipment to drill, blast, dig, and haul the ore from deeper parts of the kimberlite pipes.

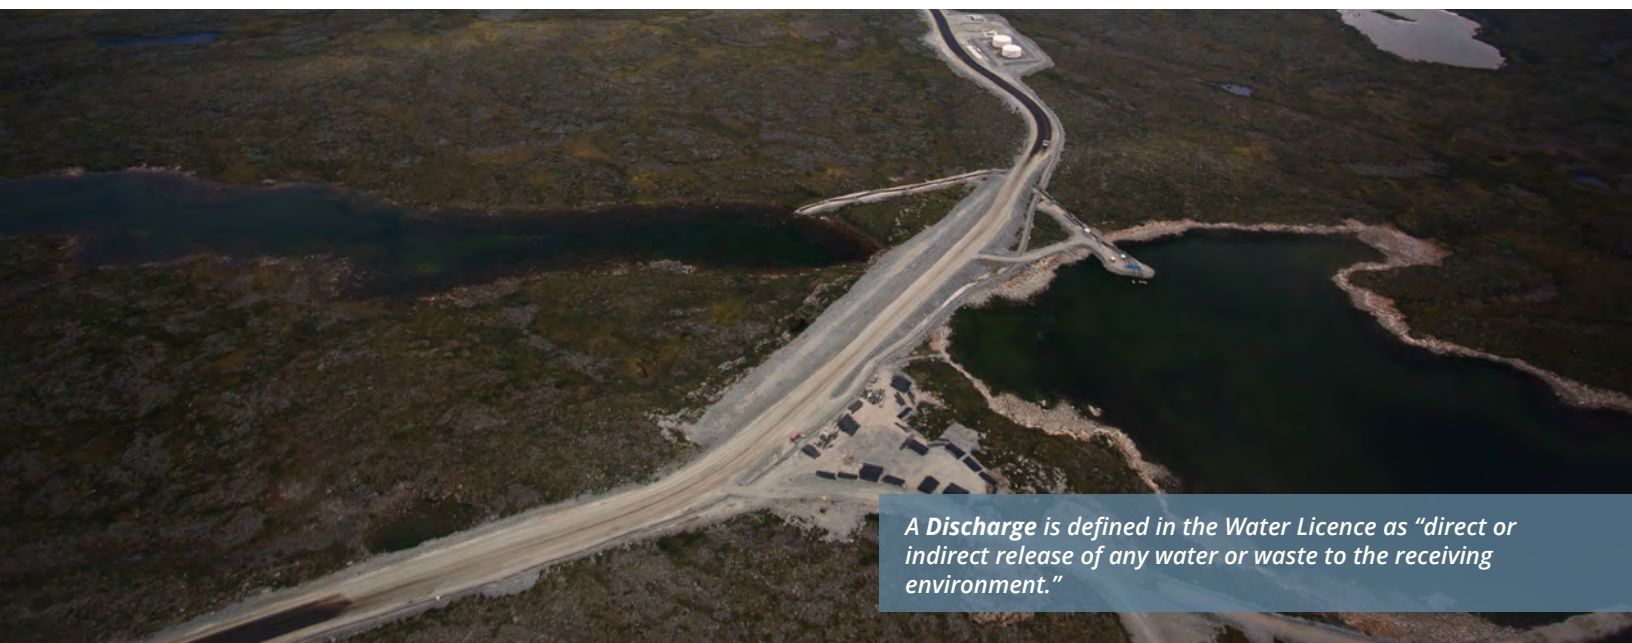
Discharge point between Long Lake Containment Facility (right) and Leslie Lake (left)

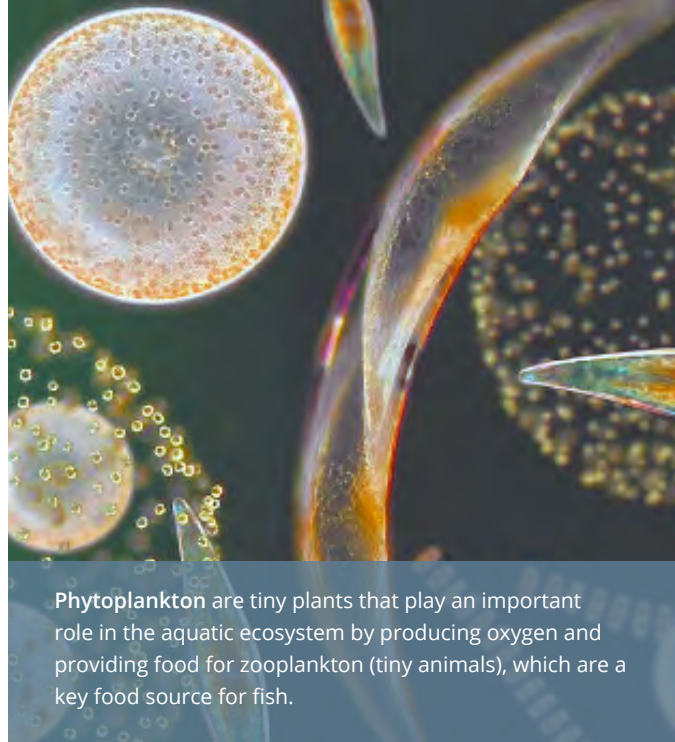
Phytoplankton are tiny plants that play an important role in the aquatic ecosystem by producing oxygen and providing food for zooplankton (tiny animals), which are a key food source for fish.

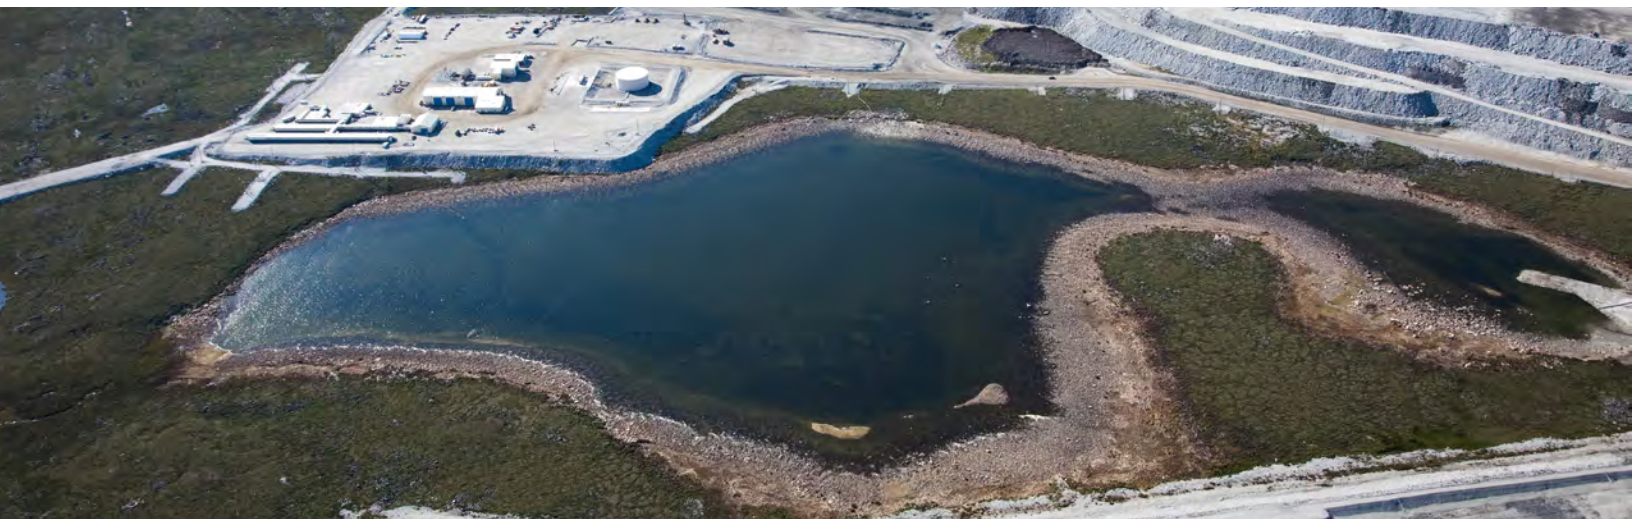
Figure 8
Summary of Water Quality and Biological Changes in the King -Cujo Watershed and Lac du Sauvage

Three of four of the water quality variables evaluated in 2019 have changed through time at monitored sites. These changes were considered potential mine-related effects, as the general pattern observed was an increase in 2008 followed by a decrease in concentrations in subsequent years.

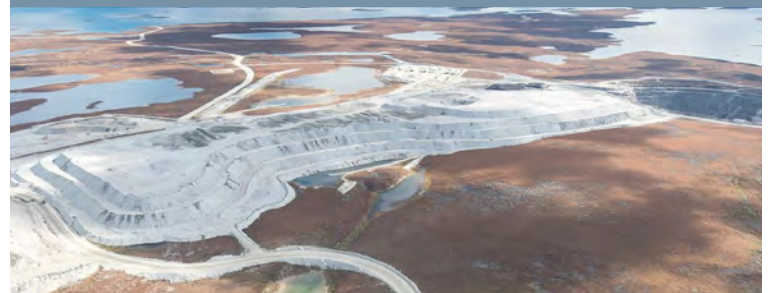
Misery Waste Rock Storage Area

Waste rock seepage refers to water that drains over and through the waste rock piles and which may pick up contaminants as it comes into contact with this material.

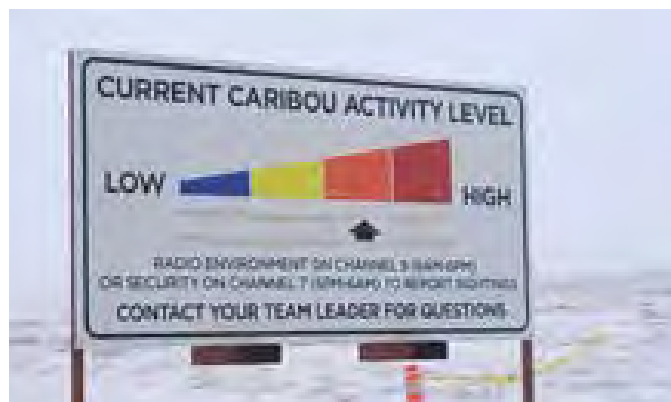
Caribou Road Mitigation Plan Activity Levels

The 2019 reporting year is the third full year that the Caribou Road Mitigation Plan has been implemented. Alert levels beyond the operational level were triggered for the entire year due to caribou occurrences near Sable or Misery roads.

Level 2 (Orange – medium risk) was in place for three periods for a total of 62 days.

Level 3 (Red – high risk) was triggered on three occasions throughout the year, for a total of 303 full days.

- Operational Level (Blue – continually)
- Level 1 (Yellow – low risk)
- Level 2 (Orange – medium risk)
- Level 3 (Red – high risk)

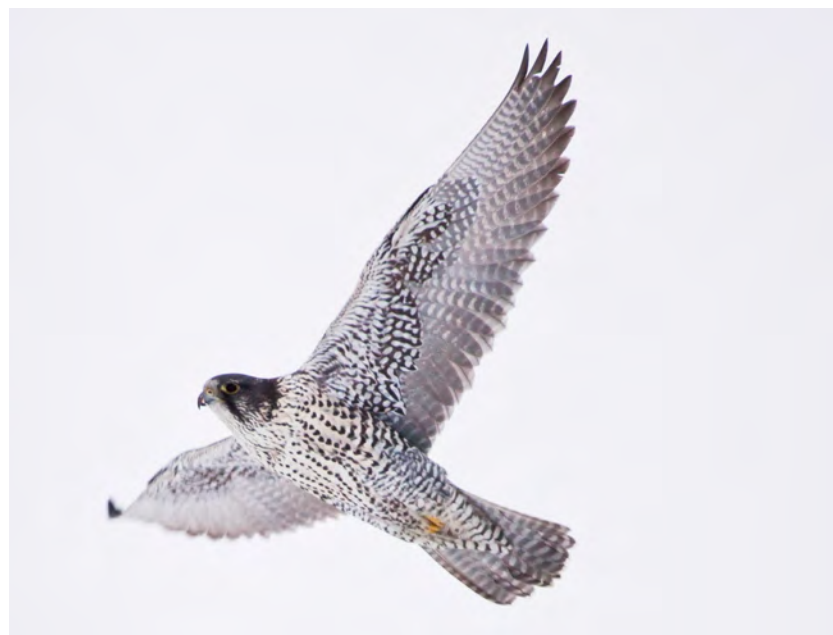
Figure 10
 Number of Birds Spotted during the Ekati Diamond Mine Bird Survey 2003 to 2019

The North American Breeding Bird Survey (NABBS) was done for the 17th year at the Ekati Diamond Mine in 2019. The NABBS is a way of surveying birds that is conducted at over 400 locations across Canada. The data, which are compiled by the Canadian Wildlife Service, helps identify bird distribution and abundance across North America. During the survey, 409 individuals of 26 species were recorded. Five species of conservation concern were observed during the 2019 breeding bird survey: red-necked phalarope, long-tailed duck, Harris's sparrow, yellow-billed loon and northern pintail. Figure 10 shows trends for some of the more common birds observed at the mine site over the past 17 years.

See figure 10 on the next page for number of birds spotted during the Ekati Diamond Mine bird survey
